RELĂȚIONAREA PROCESELOR GEOMORFOLOGICE DE RISC LA UTILIZAREA TERENURILOR ÎN BAZINUL HIDROGRAFIC CUBOLTA (REPUBLICA MOLDOVA)

Angela CANȚÎR, Ioana CHIRIAC,

RELATING GEOMORPHOLOGICAL PROCESSES TO LAND USE IN CUBOLTA RIVER BASIN (REPUBLIC OF MOLDOVA)

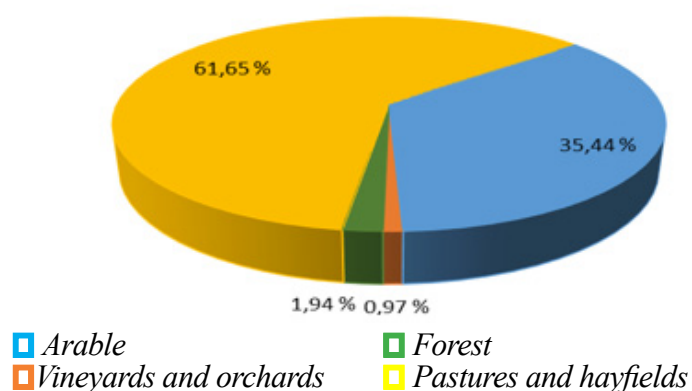
Figure 15. The share of ravines by land use category

For the *gullies*, the current situation is relatively reassuring [12, 13]. According to Figure 15 and Figure 16, most gullies (61.65%) are located on pastures and hayfields, arable land is affected by 35.44% of the total gullies, and about 3% are located on vineyards, orchards, and forests.

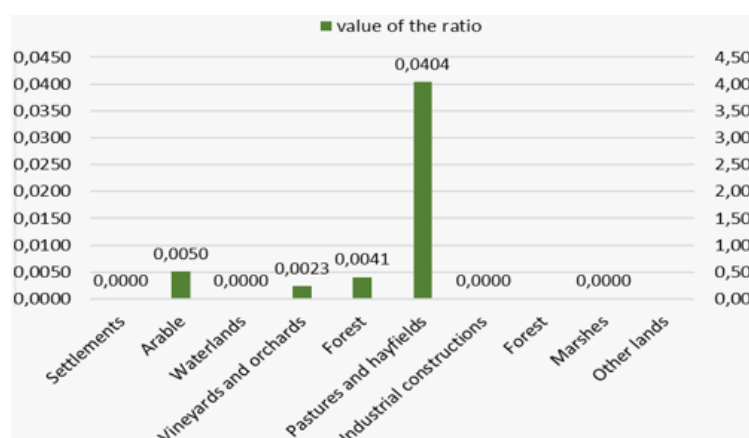
Figure 17. Correlation between land use and ravines

Taking into account the ratio between the surface of the gullies and the surface of the study area by categories of land use (Figure 17), the most affected by this process are pastures and hayfields (0.0404), followed by arable land (0.0050), forests (0, 0041), and vineyards and orchards (0.0023).
